Home Inspection Report

Inspected By: Steve Rodgers

Prepared For:
Inspected On Fri, Mar 13, 2026 at 11:00 AM

Absolute Property Inspections, LLC
(954) 348-1337
www.absoluteinspectionsbysteve.com

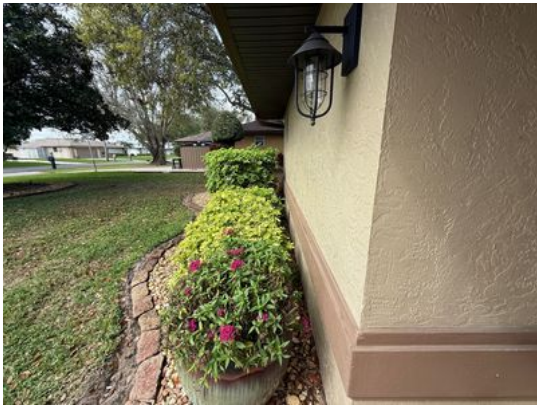
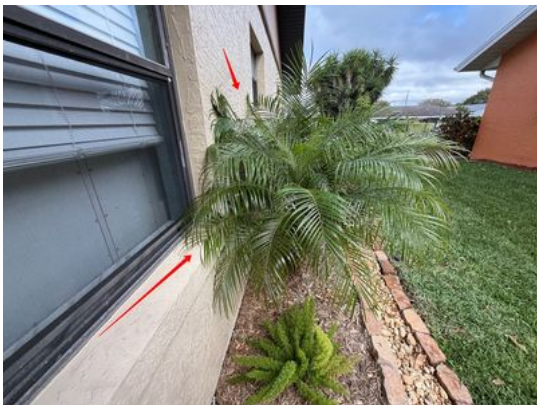
Growing Against Structure, Generally Maintained

Condition: Marginal

Preventative Maintenance: To protect the building envelope, all vegetation should be kept clear of the structure. Plants touching the house hold moisture against the stucco and roof, which can lead to Wood Decay and Insect Infestation. Regular pruning is required to maintain proper air circulation around the home's exterior.

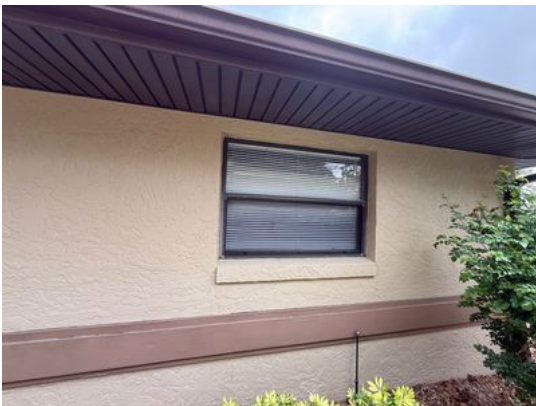
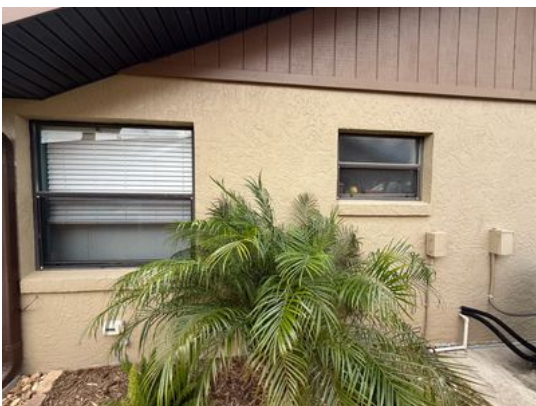
Condition: Repair or Replace

Functional Note: Window screens are considered a Standard Component of the window assembly. During the inspection, it was noted that some screens are either missing or in disrepair. This is a common maintenance item that should be addressed to allow for bug-free ventilation of the home.

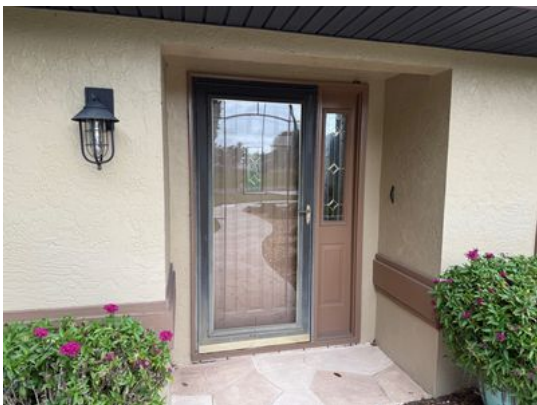
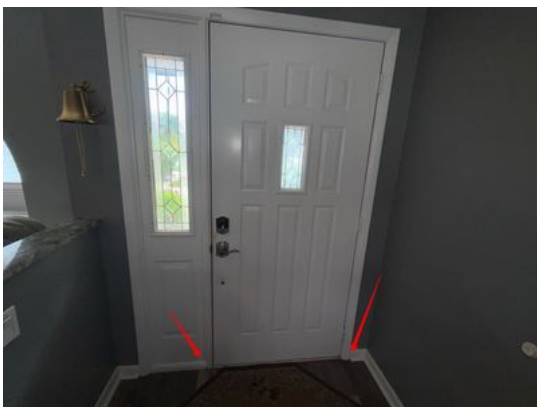
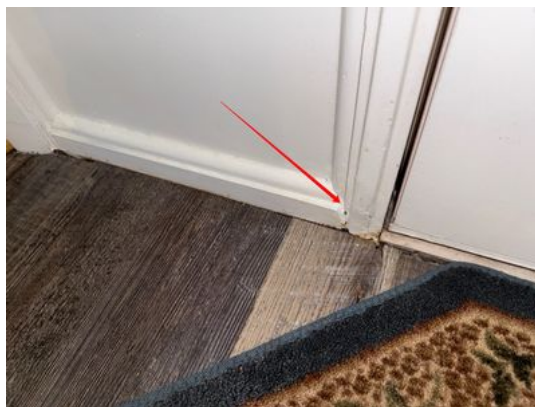
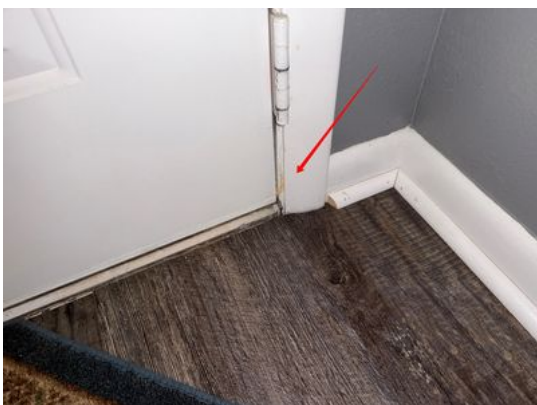
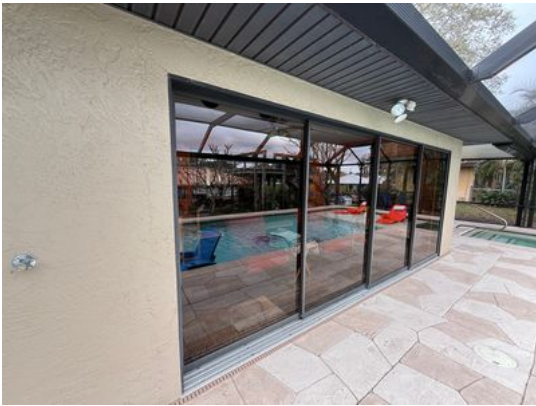
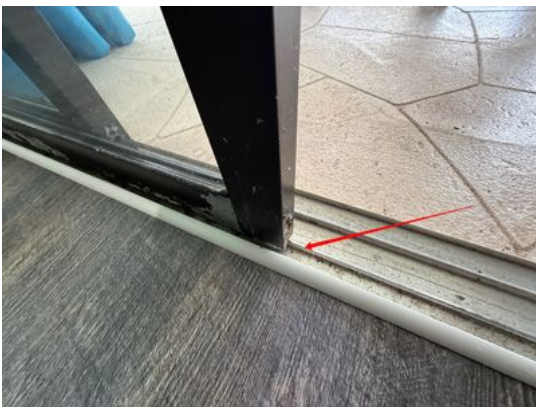
Soft, spongy, or "crumbly" wood (wood rot) observed at the base of the exterior door jamb. The door jamb is a critical structural element that supports the weight of the door and provides security. Recommend removal and replacement of the rotted sections using Pressure-Treated Lumber or a composite material. Ensure all joints are properly Caulked and Sealed after repair to prevent recurrence. Visible rust and corrosion observed at the bottom edge and corners of the exterior steel door. If left untreated, rust will eventually "eat through" the metal, compromising the door's structural integrity and security. A qualified technician should remove the rust, treat the metal with a Rust-Preventative Primer, and repaint. Severe pitting may require a Metal Filler (Bondo) or door replacement if the core is compromised. The sliding glass doors require excessive force to operate and exhibits a "grinding" sensation. A difficult-to-open door can be a hazard during an emergency egress. Clean and vacuum the tracks first. If operation does not improve, a Specialized Door Repair Professional should replace the rollers with new Stainless-Steel or Ball-Bearing Rollers and align the door.

Soft, spongy, or "crumbly" wood (wood rot) observed at the base of the exterior door jamb. The door jamb is a critical structural element that supports the weight of the door and provides security. Recommend removal and replacement of the rotted sections using Pressure-Treated Lumber or a composite material. Ensure all joints are properly Caulked and Sealed after repair to prevent recurrence. Visible rust and corrosion observed at the bottom edge and corners of the exterior steel door. If left untreated, rust will eventually "eat through" the metal, compromising the door's structural integrity and security. A qualified technician should remove the rust, treat the metal with a Rust-Preventative Primer, and repaint. Severe pitting may require a Metal Filler (Bondo) or door replacement if the core is compromised. The sliding glass

doors require excessive force to operate and exhibits a "grinding" sensation. A difficult-to-open door can be a hazard during an emergency egress. Clean and vacuum the tracks first. If operation does not improve, a Specialized Door Repair Professional should replace the rollers with new Stainless-Steel or Ball-Bearing Rollers and align the door.

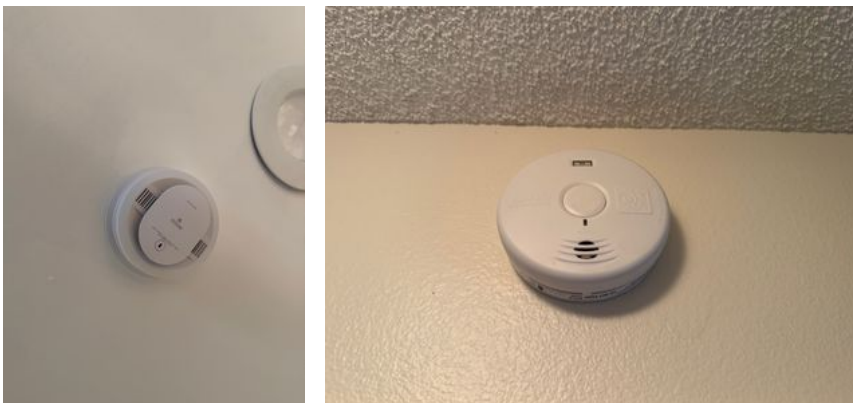
Smoke alarms were found to be missing from one or more required locations, specifically the Master Bedroom. Early detection of smoke is critical for safe egress during a fire. Missing alarms significantly increase the risk of injury or death, particularly during sleeping hours. Immediate Action Required. Install new smoke alarms in all required locations for maximum protection. 10-Year Rule: All smoke alarms should be replaced every 10 years from the date of manufacture, as sensors degrade over time.

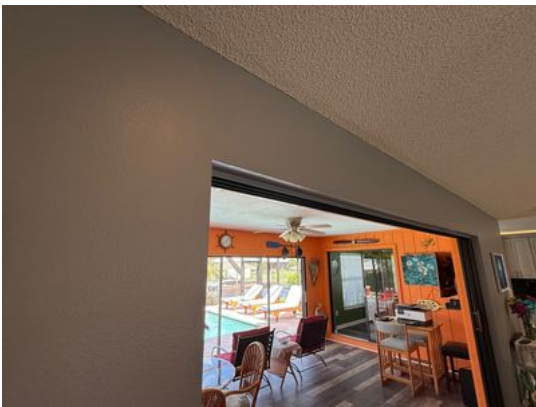
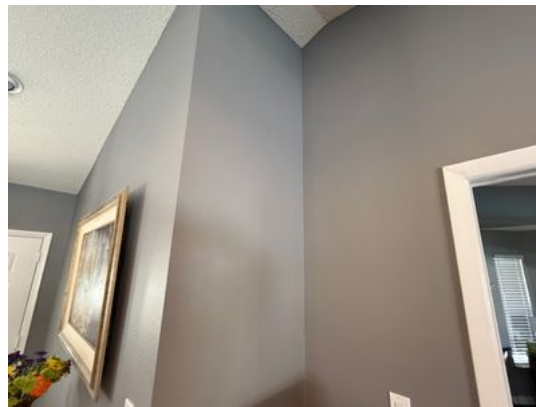
Minor scuffs, small nail holes, and slight abrasions consistent with the aging of the home and previous occupancy were observed throughout the interior. These imperfections are non-structural and do not indicate underlying moisture or movement issues. They are considered an aesthetic maintenance item for the next occupant. Recommend a routine "patch and paint" project. This involves filling small holes with a lightweight joint compound or spackle, sanding smooth, and applying a matching finish coat of paint.

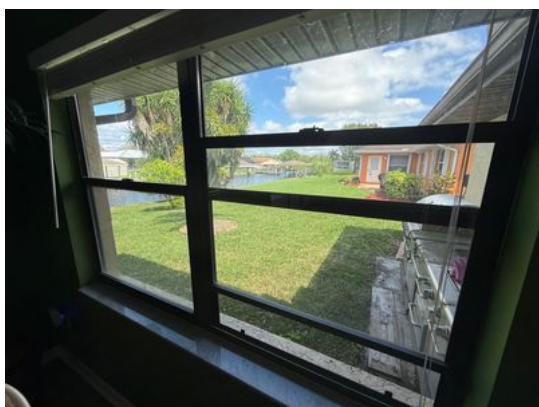
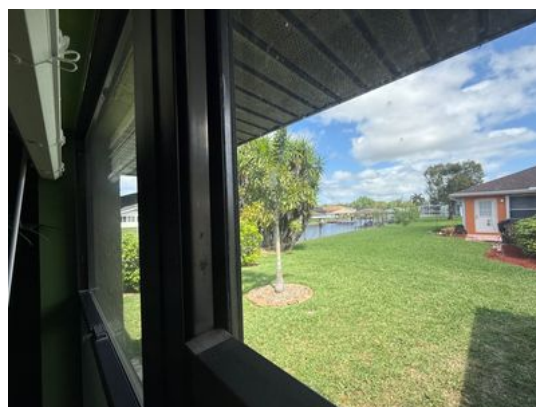
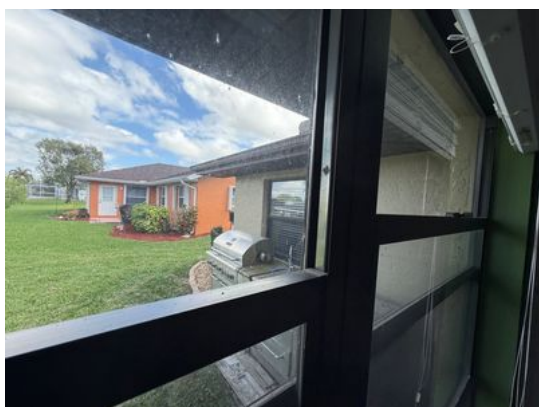
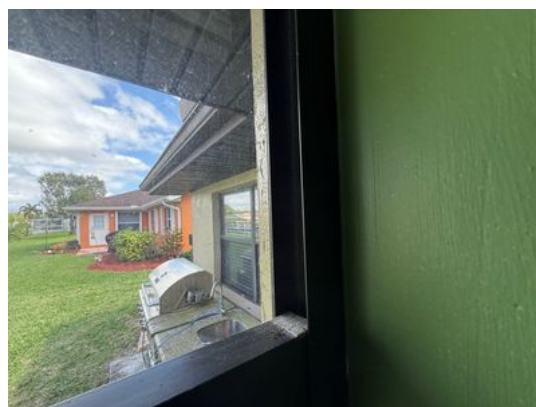
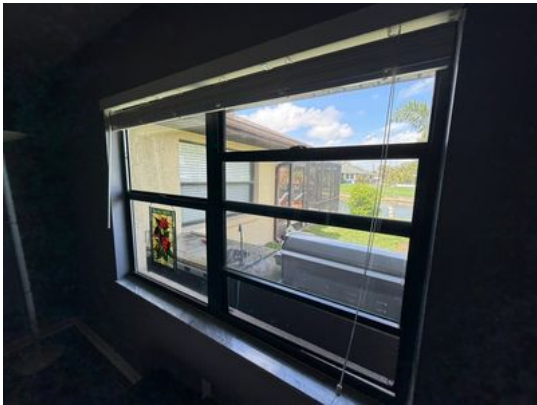
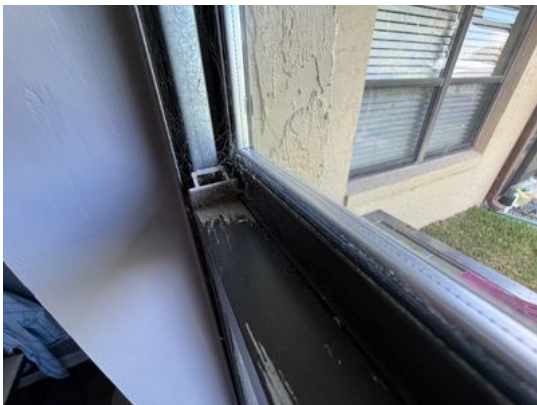
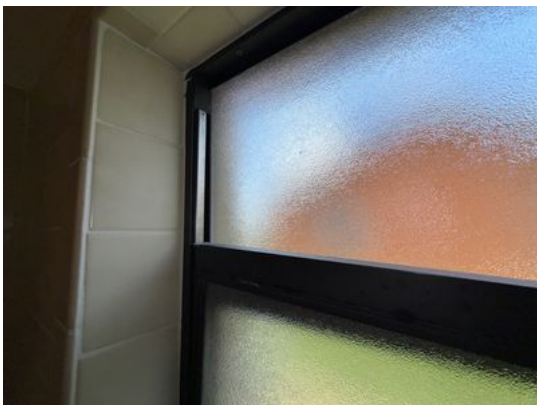
Broken Window Balancers (Single Hung). Several aluminum single-hung windows are difficult to open, and once raised, they fail to remain in the open position. Visible damage to the internal balance springs was noted. A window that won't stay open is a violation of life-safety standards for emergency escape. If the sash falls unexpectedly, it could cause severe injury to hands or fingers (the "guillotine effect"). Excessive force required to open windows can lead to damage to the window frame or glass over time. Recommend immediate repair by a Qualified Window Technician. This typically involves replacing the spiral balancers within the window tracks. For safety, do not attempt to prop these windows open with external objects. Modern building codes require that windows in Sleeping Rooms be easily operable from the interior without the use of tools, keys, or special knowledge. The observed failure of the window balancers renders these units non-compliant and poses a risk during an emergency evacuation.

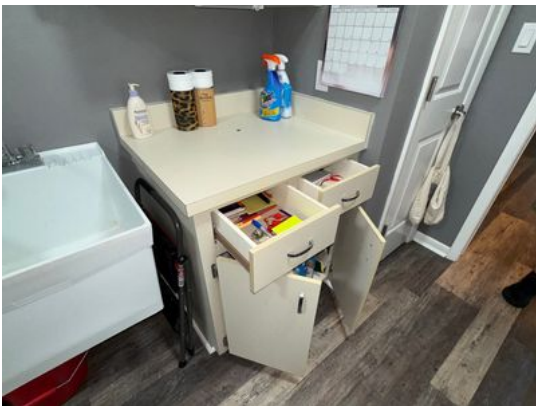
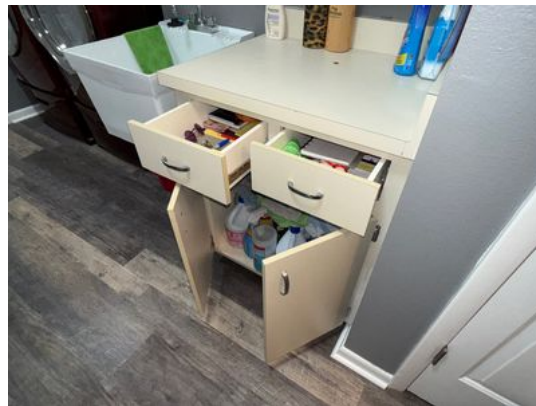
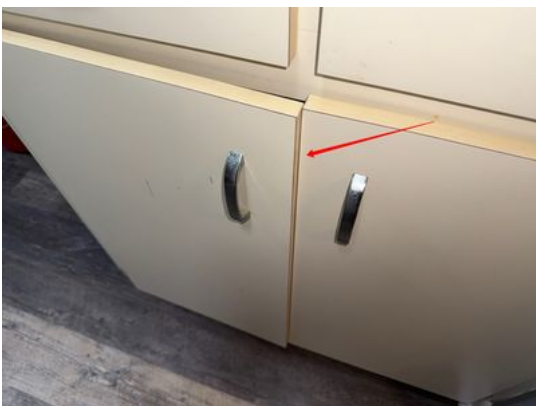
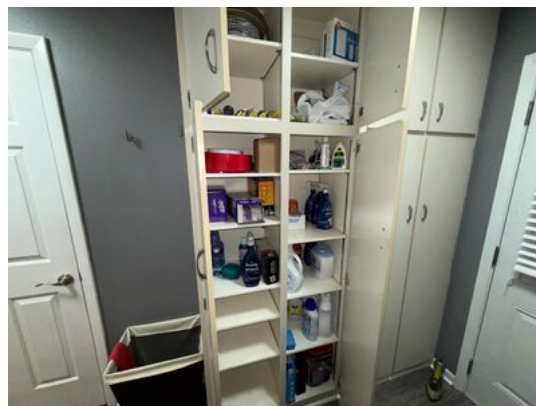
General Cabinetry Wear (Laundry Room). Minor scuffs, small nicks in the laminate/wood finish, and light surface staining consistent with typical household laundry use. These findings are aesthetic in nature and do not affect the structural capacity of the cabinets. Recommend routine maintenance, including cleaning with mild detergent, tightening loose hinges, and applying touch-up paint or laminate adhesive where minor peeling is present. Loose Hinges / Misaligned Doors. Common in laundry rooms where cabinets are frequently opened or vibration from the washing machine occurs. Tighten all hinge adjustment screws to restore proper door reveal and closure.

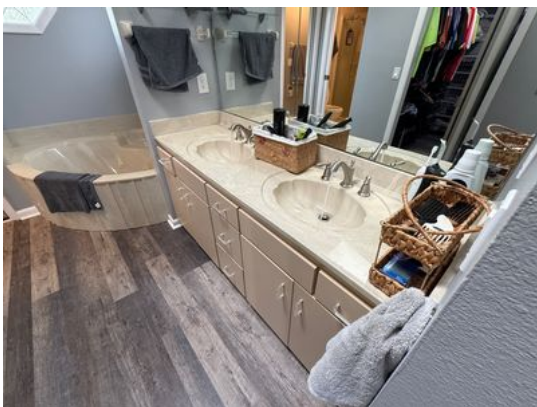
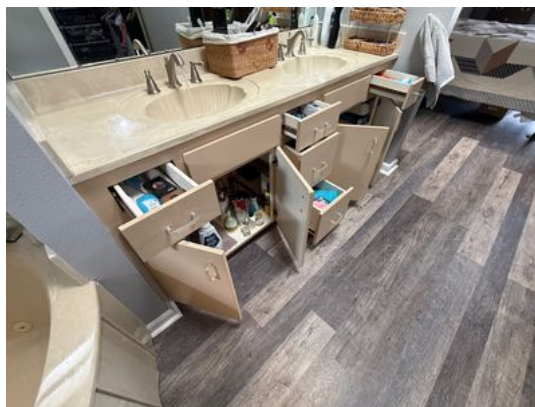
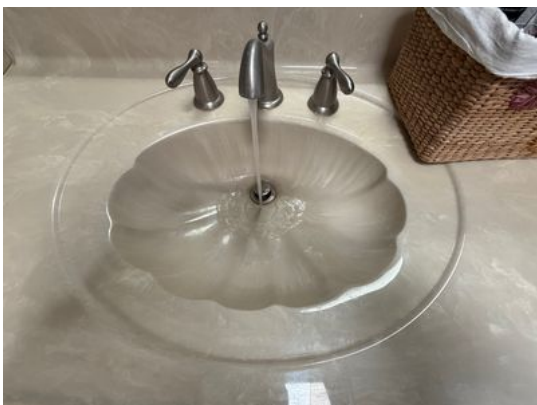
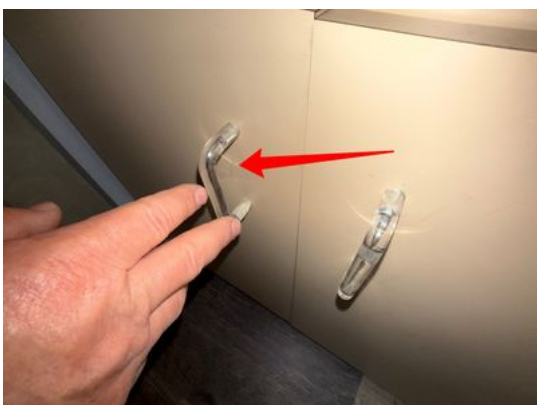
Normal Wear & Tear (Hardware). Cabinet door handles and drawer pulls were found to be loose or wobbly. This is a typical result of regular use over time. If not tightened, loose hardware can lead to stripped screw holes or damage to the cabinet face. Tighten all mounting screws. If holes are stripped, a Qualified Handyman can use wood filler or longer screws to secure the hardware. Minor Moisture/Cleaner Damage. Localized swelling, bubbling, or finish "clouding" observed at the bottom edges of the vanity cabinet and base. This is often caused by "top-down" moisture, such as dripping hands, wet towels, or the use of Harsh Chemical Cleaners that strip the protective finish. Sand affected edges and apply a Water-Resistant Sealant or Touch-up Paint to prevent further absorption.

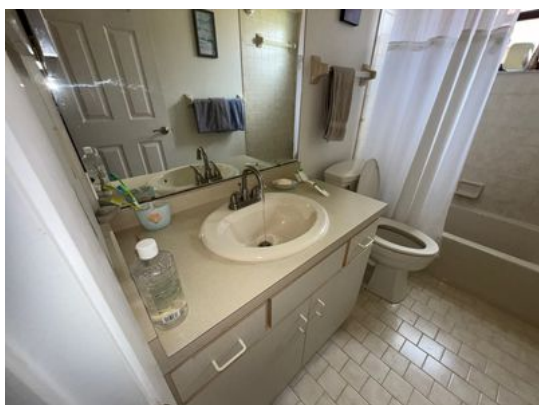
Loose Hinges / Misaligned Doors. Tighten all hinge adjustment screws to restore proper door reveal and closure.

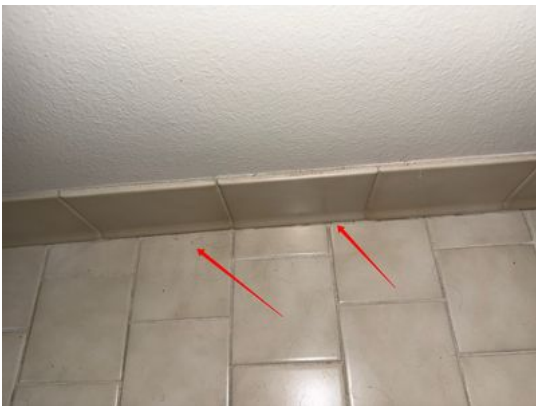
Missing/Deteriorated Floor Grout. Several areas of the tiled floor exhibit missing, cracked, or eroded grout. The damage appears consistent with age and normal foot traffic (wear and tear). Recommend a Qualified Flooring Professional or handyman remove the loose material and regrout the affected areas. Following repair, the grout should be treated with a High-Quality Sealer to extend its service life.

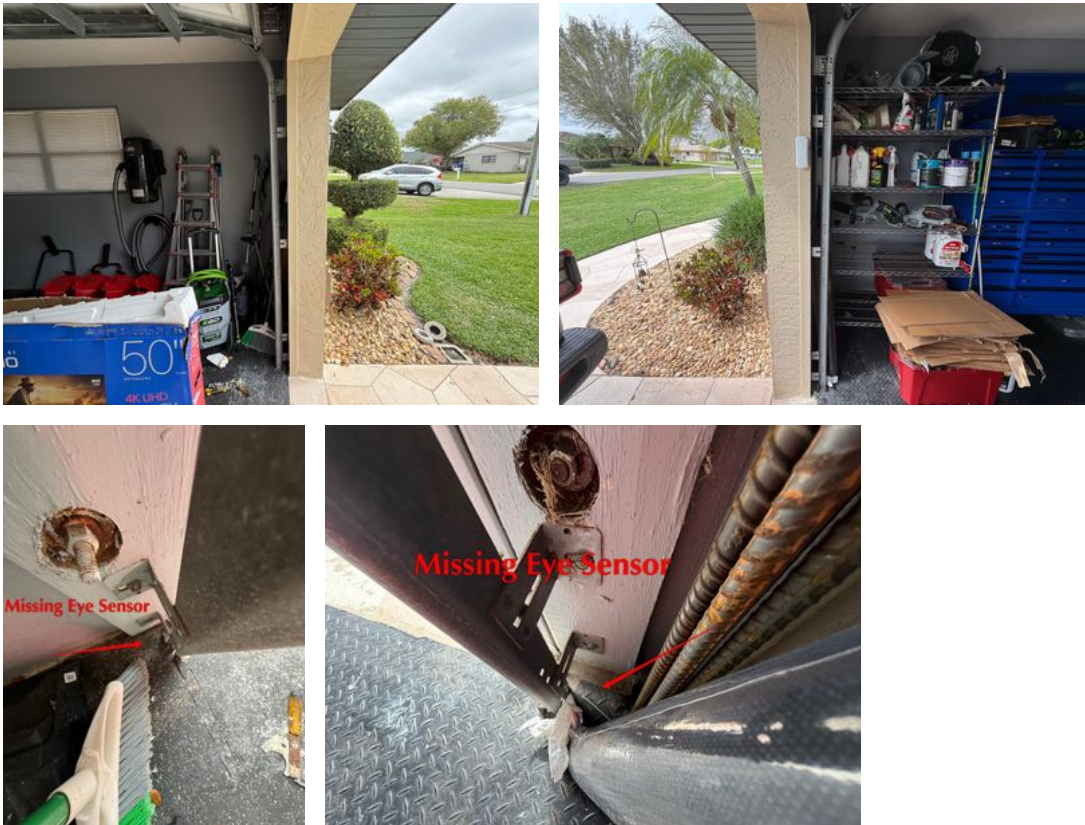
Missing Photo-Electric Safety Sensors (Safety Eyes). The automatic garage door operator is missing the required photo-electric safety sensors designed to detect obstructions in the door's path. Entrapment Risk: Without these sensors, the door may not automatically reverse if a person, pet, or object is underneath it during closure. This poses a significant risk of serious injury or death from crushing. Code Non-Compliance: Automatic openers manufactured or installed after January 1, 1993, must be equipped with a secondary entrapment protection system (like safety eyes) to meet UL 325 standards. Immediate Repair Required. A Qualified Garage Door Technician should be engaged to install a compatible safety sensor kit. If the existing opener is an older model (pre-1993) that cannot support sensors, the entire motor unit should be replaced with a modern, compliant system.

Missing Photo-Electric Safety Sensors (Safety Eyes). The automatic garage door opener is missing the required photo-electric safety sensors designed to detect obstructions in the door's path. Entrapment Risk: Without these sensors, the door may not automatically reverse if a person, pet, or object is underneath it during closure. This poses a significant risk of serious injury or death from crushing. Code Non-Compliance: Automatic openers manufactured or installed after January 1, 1993, must be equipped with a secondary entrapment protection system (like safety eyes) to meet UL 325 standards. Immediate Repair Required. A Qualified Garage Door Technician should be engaged to install a compatible safety sensor kit. If the existing opener is an older model (pre-1993) that cannot support sensors, the entire motor unit should be replaced with a modern, compliant system.
