Home Inspection Report

Inspected By: Steve Rodgers

Prepared For:
Inspected On Fri, Mar 13, 2026 at 11:00 AM

Absolute Property Inspections, LLC
(954) 348-1337
www.absoluteinspectionsbysteve.com

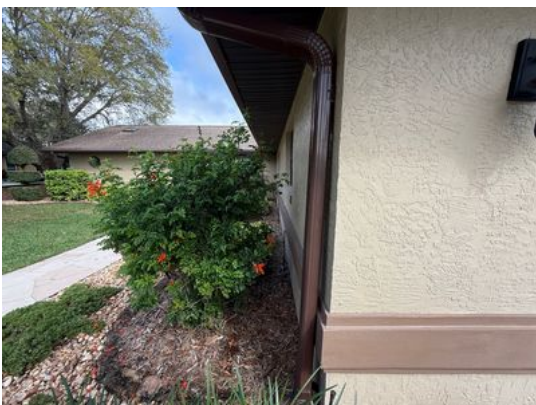
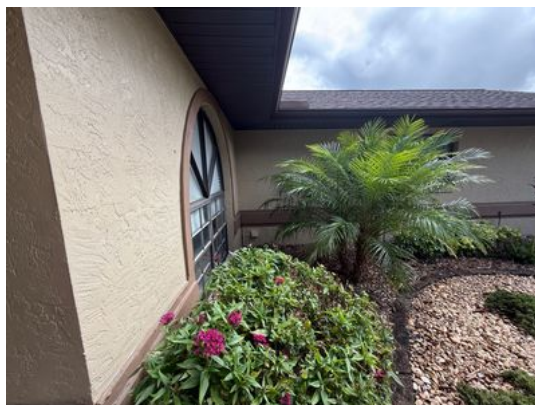
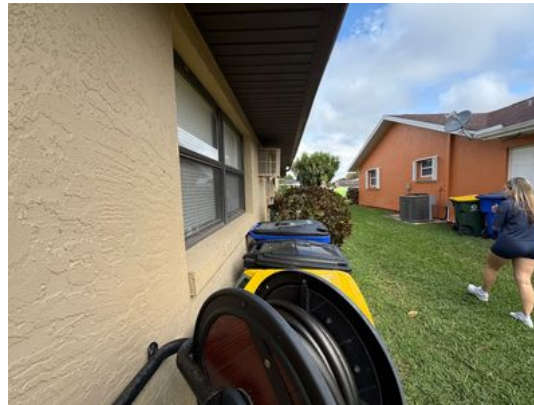
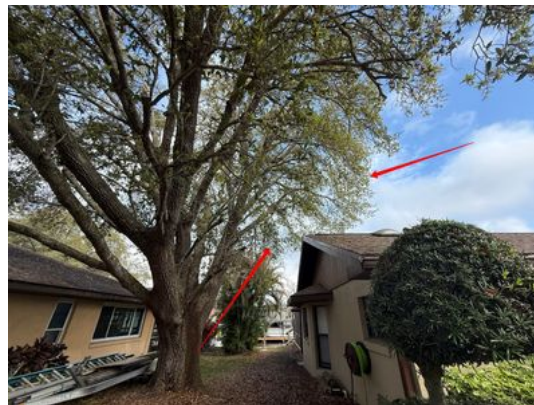
Vegetation

Growing Against Structure, Generally Maintained

Condition: Marginal

Preventative Maintenance: To protect the building envelope, all vegetation should be kept clear of the structure. Plants touching the house hold moisture against the stucco and roof, which can lead to Wood Decay and Insect Infestation. Regular pruning is required to maintain proper air circulation around the home's exterior.

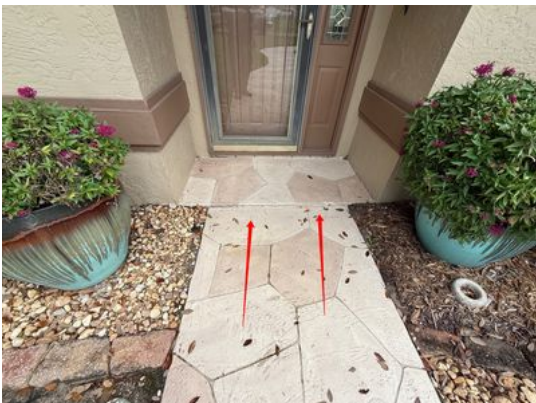
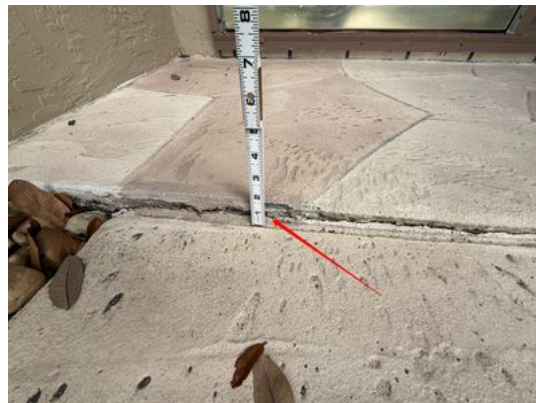
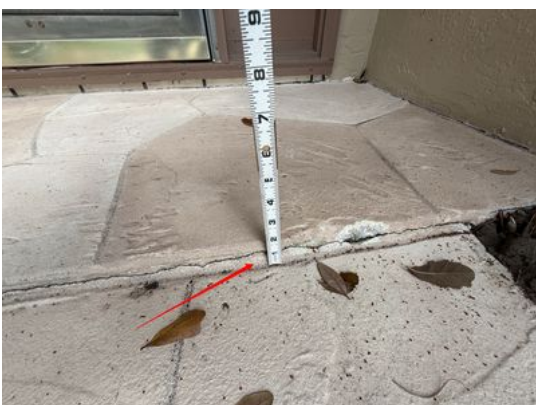
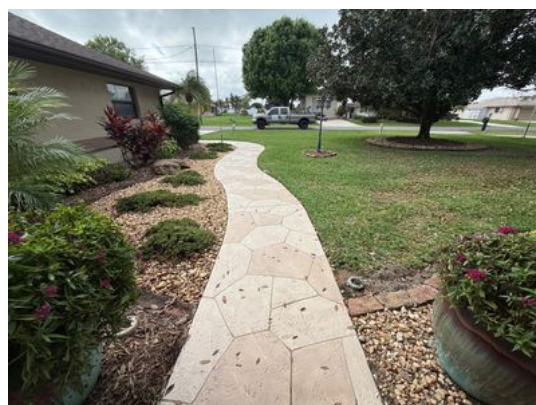
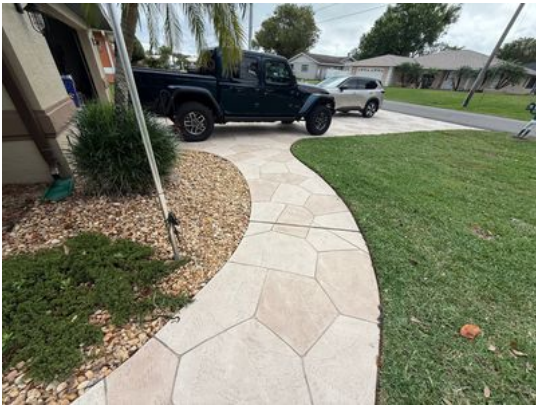
Walkways

Stamped Concrete

Condition: Marginal

Safety Warning: Pedestrians typically scan ahead rather than directly at their feet. Vertical edges as low as 3/8 inch have been identified as primary causes of falls. To maintain a safe walking surface, all vertical offsets must be addressed.

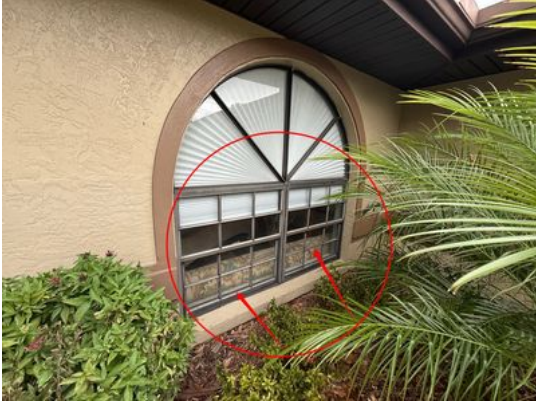
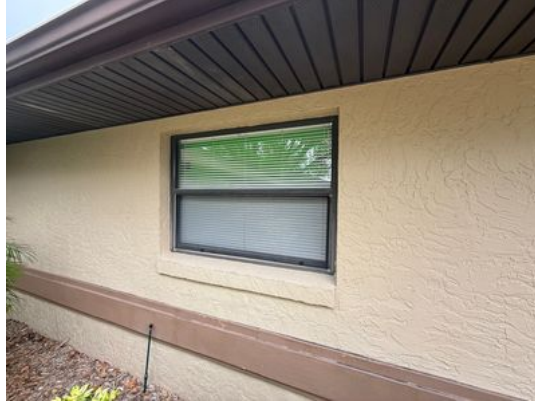
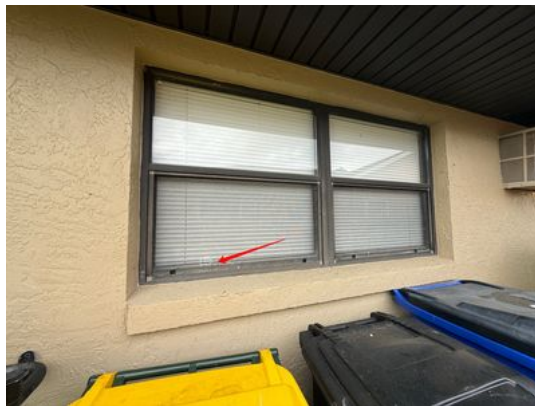
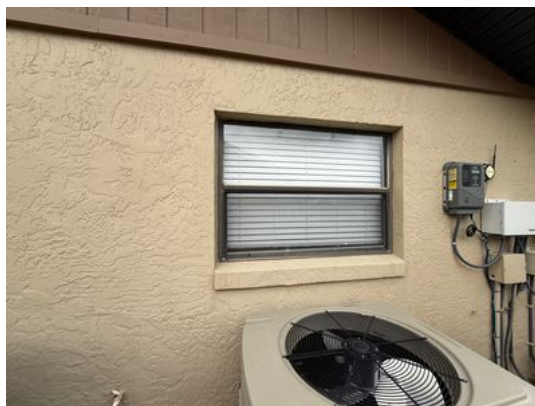
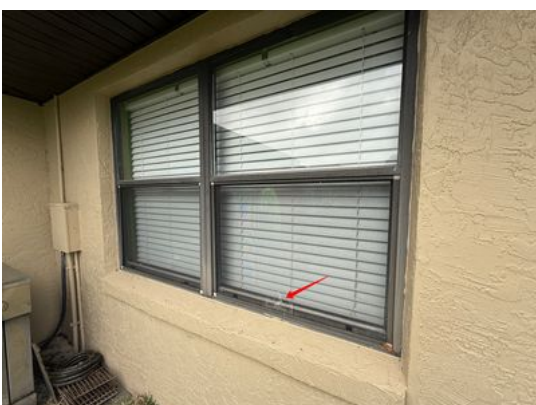
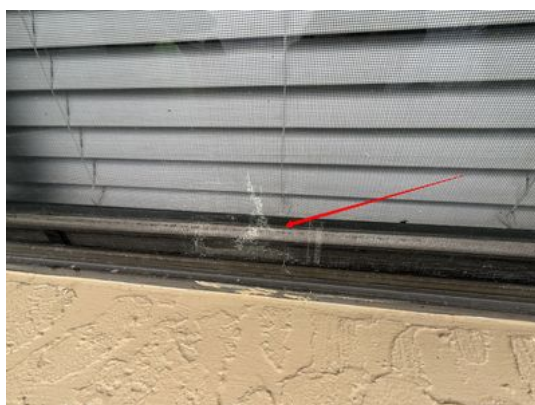
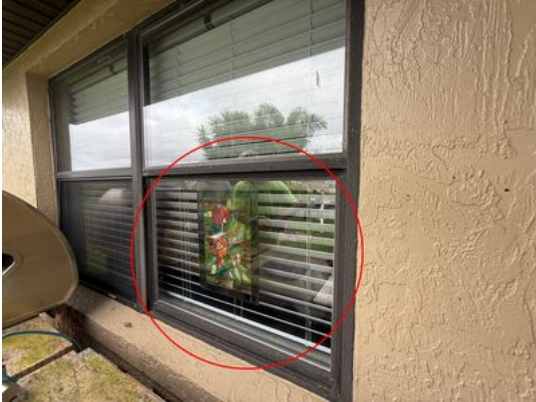
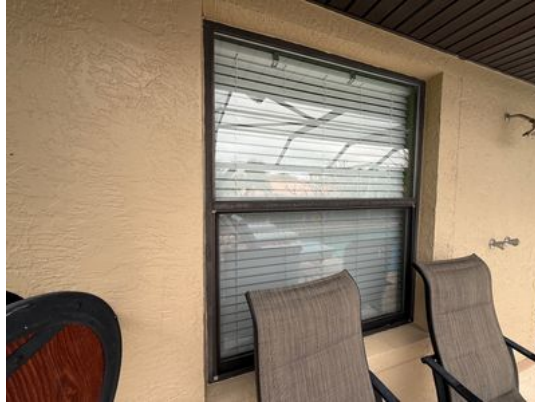
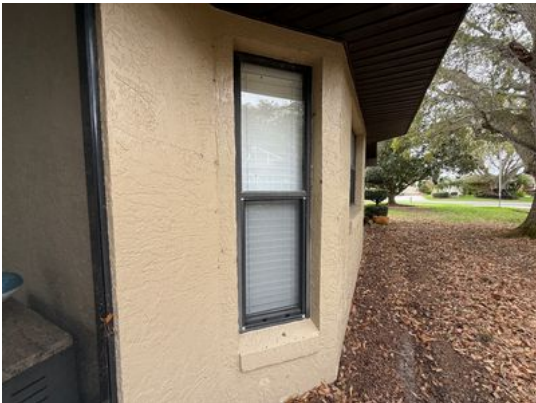
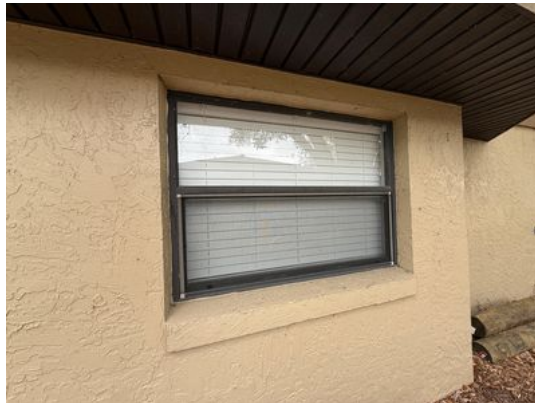
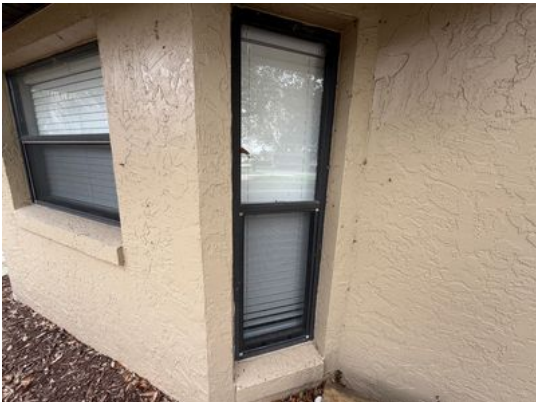
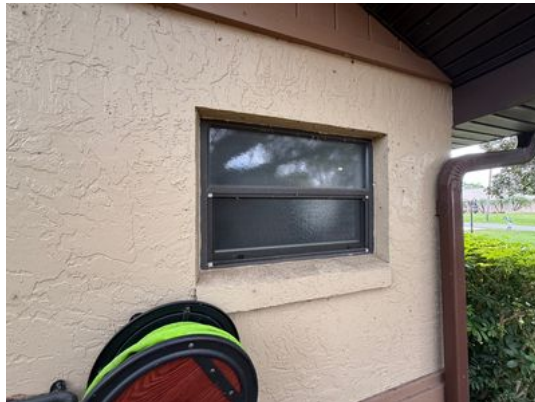
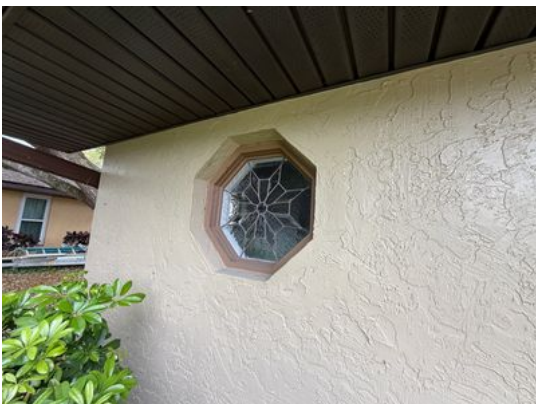
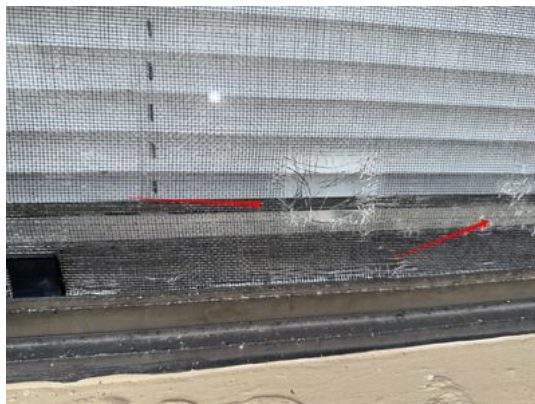
Windows

Condition: Repair or Replace

Repair or Replacement Needed

Functional Note: Window screens are considered a Standard Component of the window assembly. During the inspection, it was noted that some screens are either missing or in disrepair. This is a common maintenance item that should be addressed to allow for bug-free ventilation of the home.

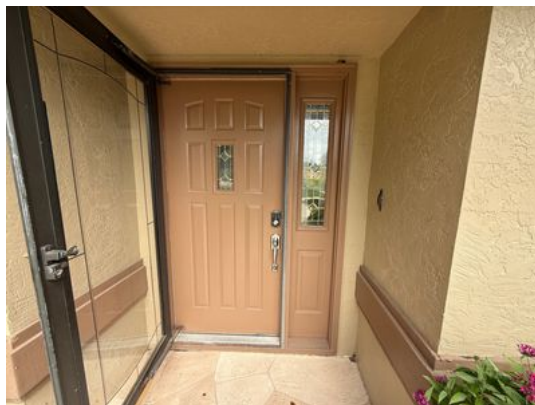
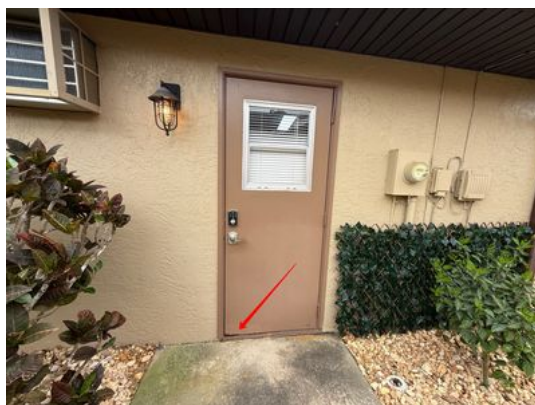
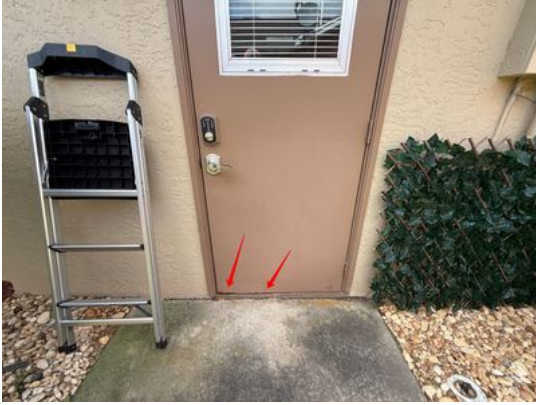
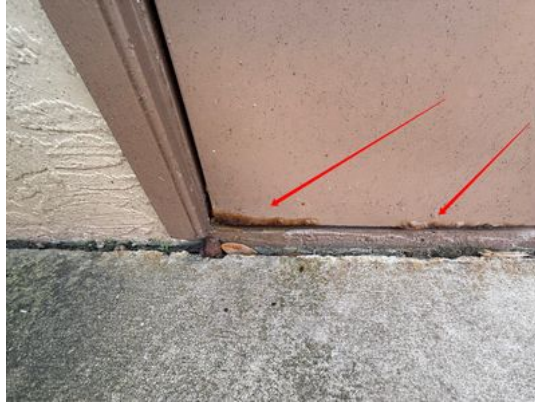
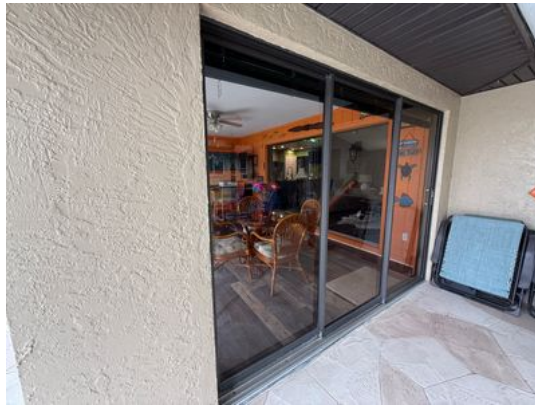
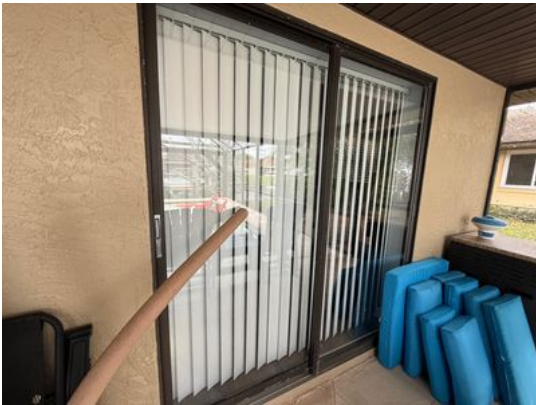
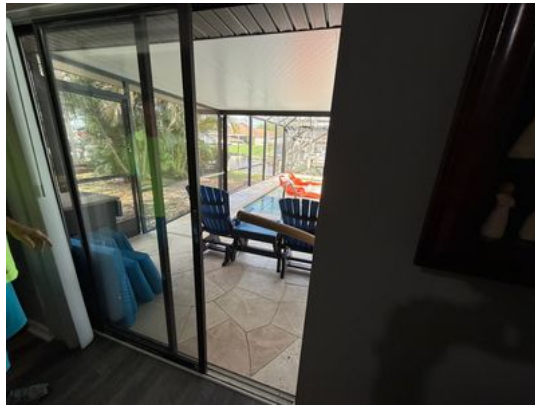
Steel, Sliding Glass Door

Condition: Marginal

Repair or Replacement Needed

Soft, spongy, or "crumbly" wood (wood rot) observed at the base of the exterior door jamb. The door jamb is a critical structural element that supports the weight of the door and provides security. Recommend removal and replacement of the rotted sections using Pressure-Treated Lumber or a composite material. Ensure all joints are properly Caulked and Sealed after repair to prevent recurrence. Visible rust and corrosion observed at the bottom edge and corners of the exterior steel door. If left untreated, rust will eventually "eat through" the metal, compromising the door's structural integrity and security. A qualified technician should remove the rust, treat the metal with a Rust-Preventative Primer, and repaint. Severe pitting may require a Metal Filler (Bondo) or door replacement if the core is compromised. The sliding glass doors require excessive force to operate and exhibits a "grinding" sensation. A difficult-to-open door can be a hazard during an emergency egress. Clean and vacuum the tracks first. If operation does not improve, a Specialized Door Repair Professional should replace the rollers with new Stainless-Steel or Ball-Bearing Rollers and align the door.

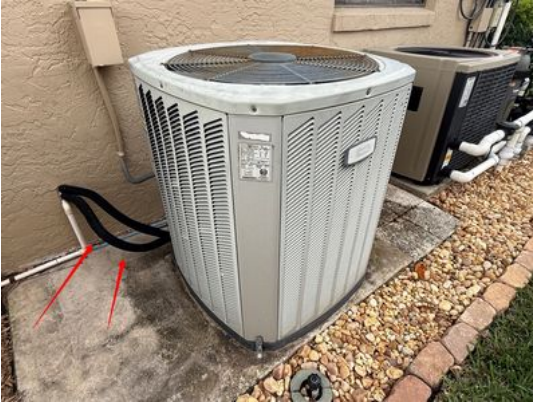
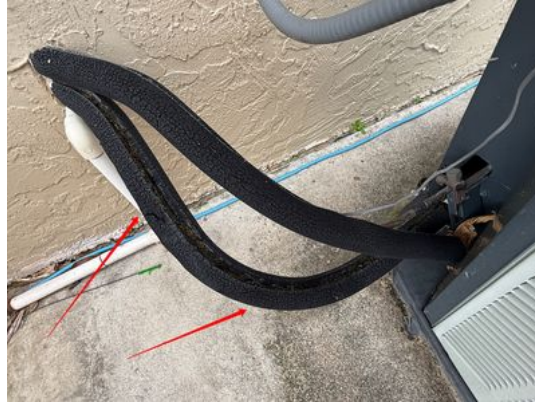
Deficiency: Dry-Rotted Suction Line Insulation

Description: The thermal insulation on the refrigerant suction line is dry-rotted, crumbling, or missing in several sections.

Condensation & Corrosion: The uninsulated cold pipe will "sweat" in humid conditions. This moisture can lead to localized corrosion at the service valves or drip onto the building's foundation, contributing to long-term moisture issues.

System Lifespan: Increased operational strain on the compressor can shorten the overall life expectancy of the unit.

Recommendation: Recommend a Licensed HVAC Professional or qualified technician remove the failed material and install new UV-Resistant, Closed-Cell Insulation.

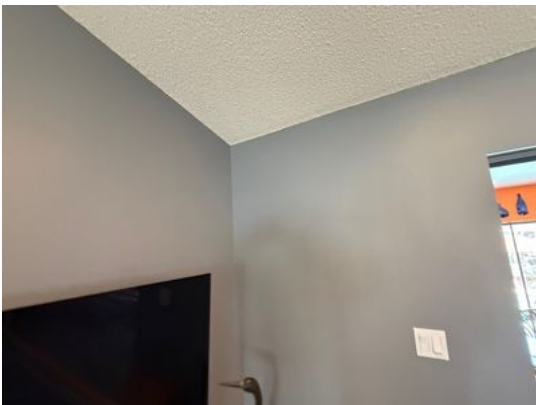
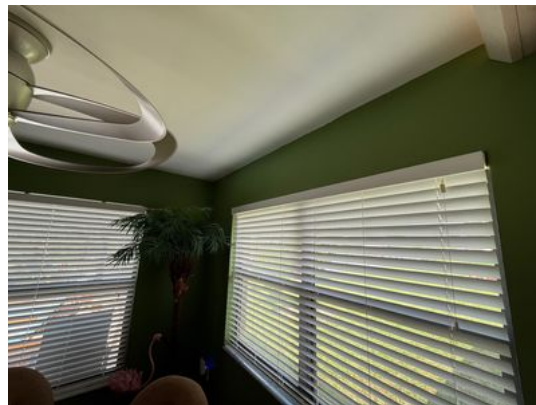
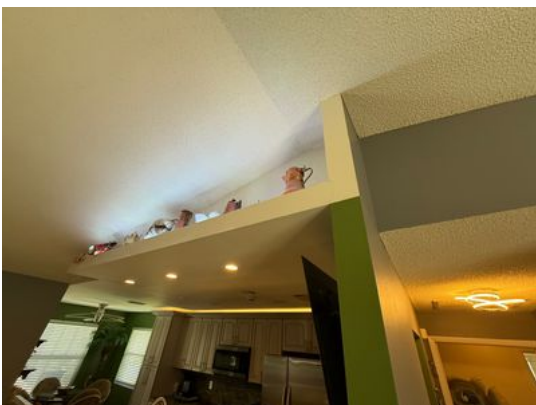
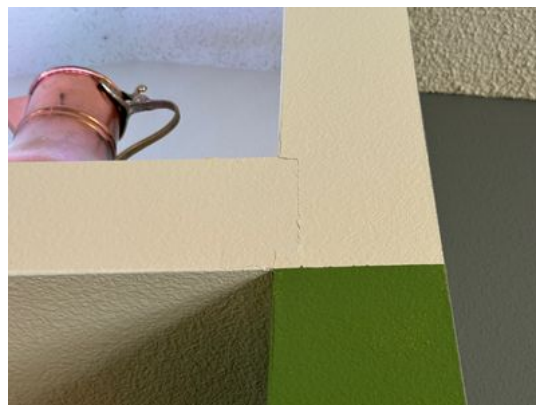
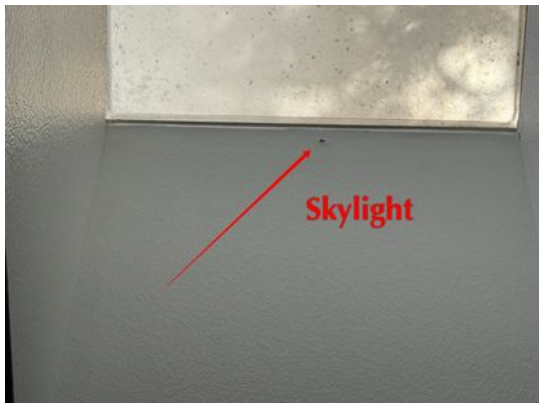
Condition: Marginal

Minor scuffs, small nail holes, and slight abrasions consistent with the aging of the home and previous occupancy were observed throughout the interior. These imperfections are non-structural and do not indicate underlying moisture or movement issues. They are considered an aesthetic maintenance item for the next occupant. Recommend a routine "patch and paint" project. This involves filling small holes with a lightweight joint compound or spackle, sanding smooth, and applying a matching finish coat of paint.

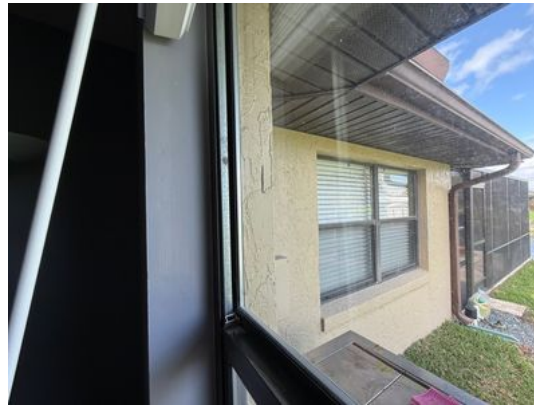
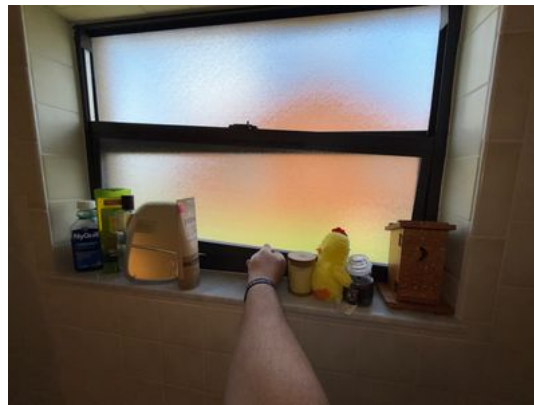
Broken Window Balancers (Single Hung). Several aluminum single-hung windows are difficult to open, and once raised, they fail to remain in the open position. Visible damage to the internal balance springs was noted. A window that won't stay open is a violation of life-safety standards for emergency escape. If the sash falls unexpectedly, it could cause severe injury to hands or fingers (the "guillotine effect"). Excessive force required to open windows can lead to damage to the window frame or glass over time. Recommend immediate repair by a Qualified Window Technician. This typically involves replacing the spiral balancers within the window tracks. For safety, do not attempt to prop these windows open with external objects. Modern building codes require that windows in Sleeping Rooms be easily operable from the interior without the use of tools, keys, or special knowledge. The observed failure of the window balancers renders these units non-compliant and poses a risk during an emergency evacuation.

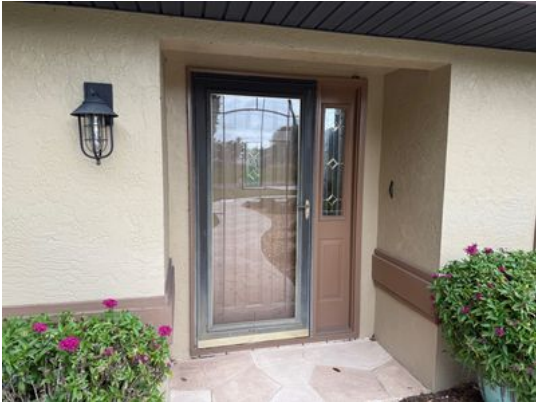
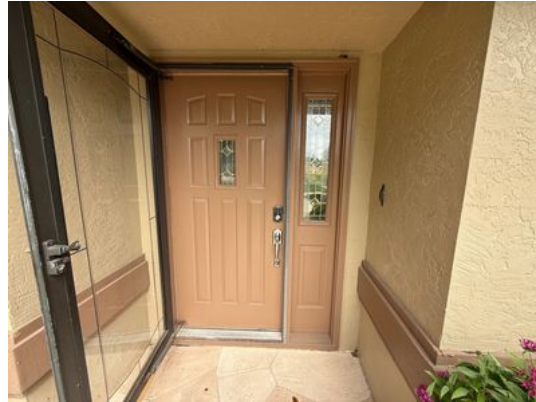
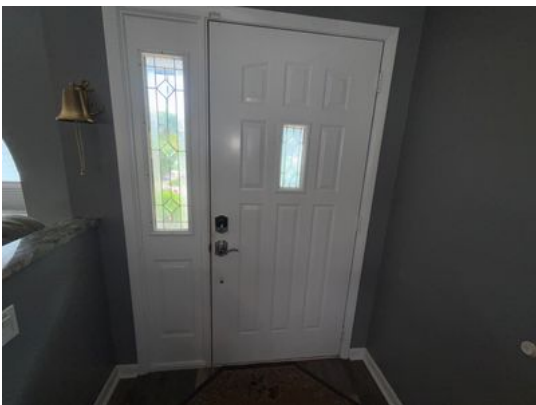
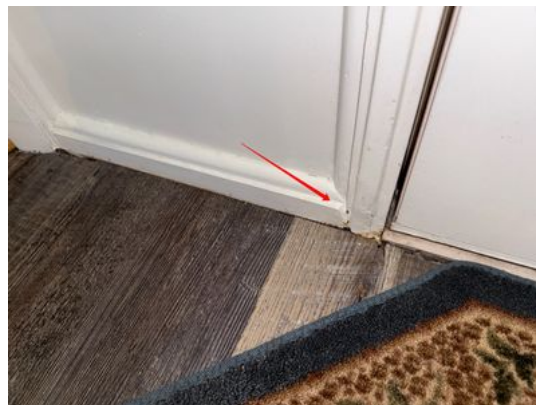
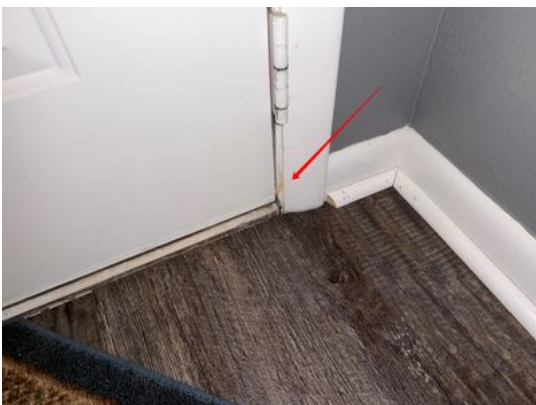
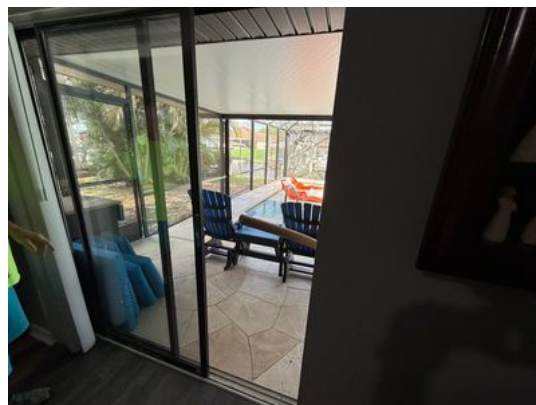
Condition: Marginal

Soft, spongy, or "crumbly" wood (wood rot) observed at the base of the exterior door jamb. The door jamb is a critical structural element that supports the weight of the door and provides security. Recommend removal and replacement of the rotted sections using Pressure-Treated Lumber or a composite material. Ensure all joints are properly Caulked and Sealed after repair to prevent recurrence. Visible rust and corrosion observed at the bottom edge and corners of the exterior steel door. If left untreated, rust will eventually "eat through" the metal, compromising the door's structural integrity and security. A qualified technician should remove the rust, treat the metal with a Rust-Preventative Primer, and repaint. Severe pitting may require a Metal Filler (Bondo) or door replacement if the core is compromised. The sliding glass doors require excessive force to operate and exhibits a "grinding" sensation. A difficult-to-open door can be a hazard during an emergency egress. Clean and vacuum the tracks first. If operation does not improve, a Specialized Door Repair Professional should replace the rollers with new Stainless-Steel or Ball-Bearing Rollers and align the door.

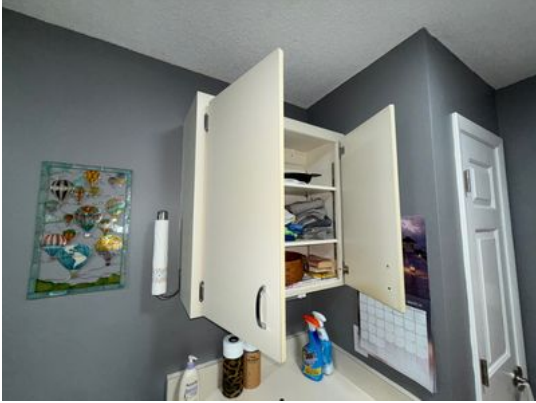
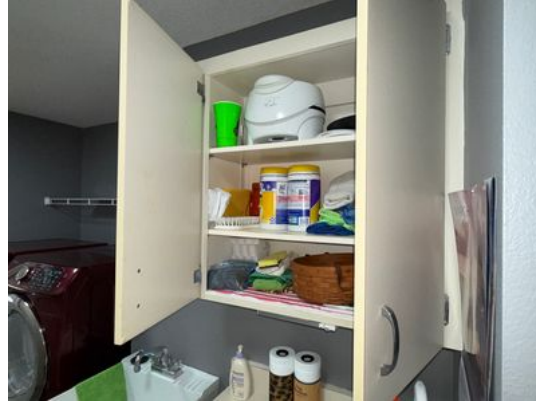
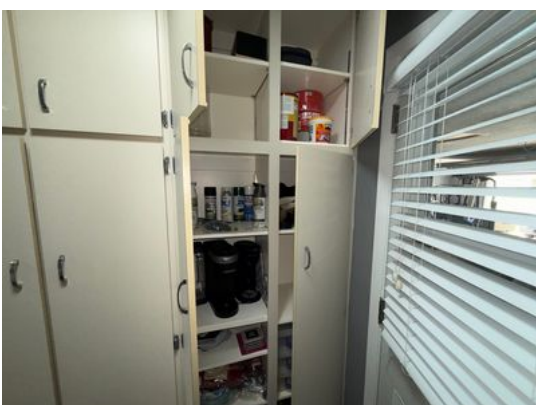
Condition: Marginal

General Cabinetry Wear (Laundry Room). Minor scuffs, small nicks in the laminate/wood finish, and light surface staining consistent with typical household laundry use. These findings are aesthetic in nature and do not affect the structural capacity of the cabinets. Recommend routine maintenance, including cleaning with mild detergent, tightening loose hinges, and applying touch-up paint or laminate adhesive where minor peeling is present. Loose Hinges / Misaligned Doors. Common in laundry rooms where cabinets are frequently opened or vibration from the washing machine occurs. Tighten all hinge adjustment screws to restore proper door reveal and closure.

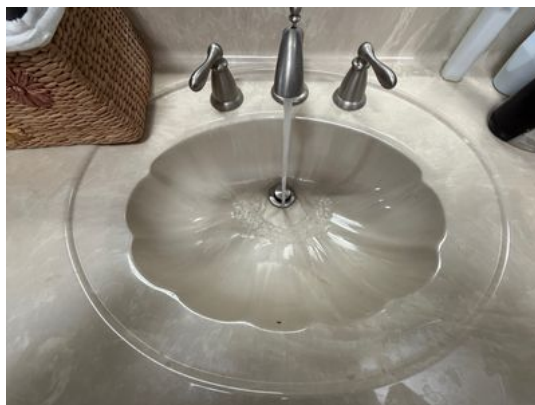
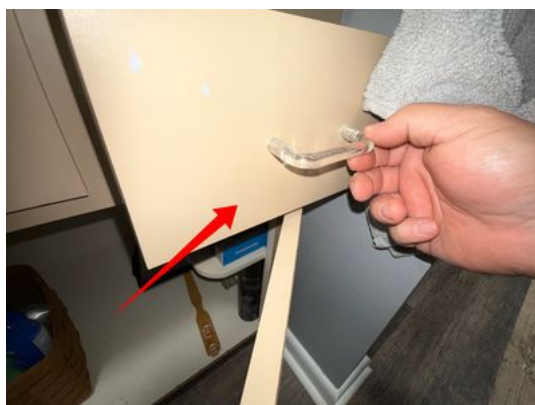
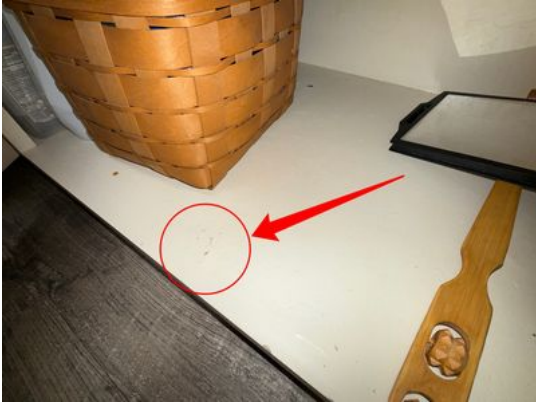
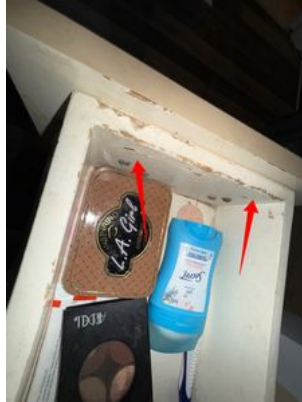
Normal Wear & Tear (Hardware). Cabinet door handles and drawer pulls were found to be loose or wobbly. This is a typical result of regular use over time. If not tightened, loose hardware can lead to stripped screw holes or damage to the cabinet face. Tighten all mounting screws. If holes are stripped, a Qualified Handyman can use wood filler or longer screws to secure the hardware. Minor Moisture/Cleaner Damage. Localized swelling, bubbling, or finish "clouding" observed at the bottom edges of the vanity cabinet and base. This is often caused by "top-down" moisture, such as dripping hands, wet towels, or the use of Harsh Chemical Cleaners that strip the protective finish. Sand affected edges and apply a Water-Resistant Sealant or Touch-up Paint to prevent further absorption.

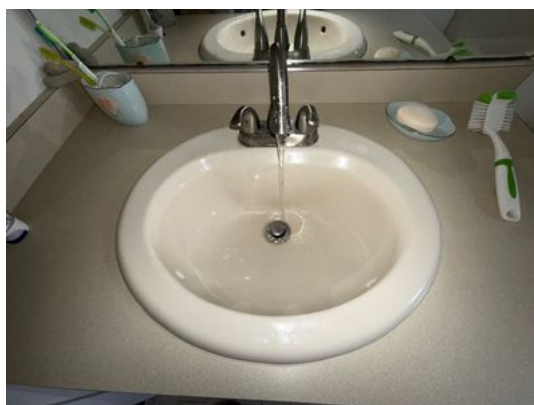
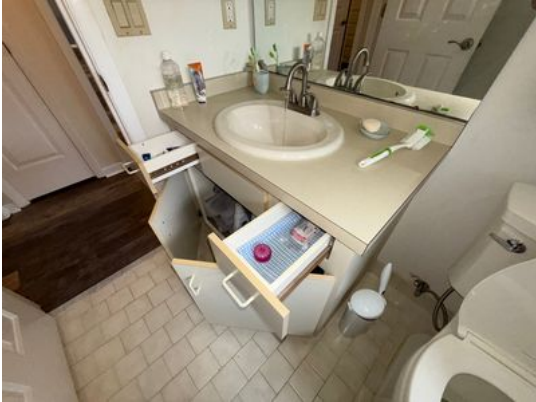
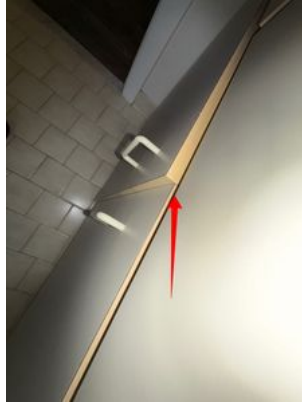
Loose Hinges / Misaligned Doors. Tighten all hinge adjustment screws to restore proper door reveal and closure.

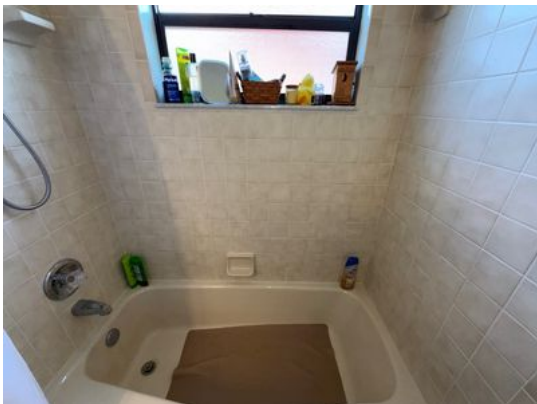
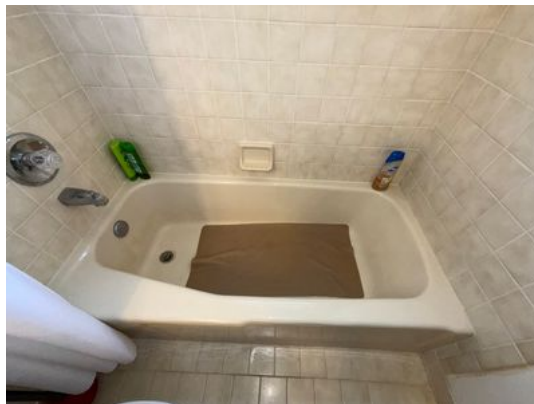
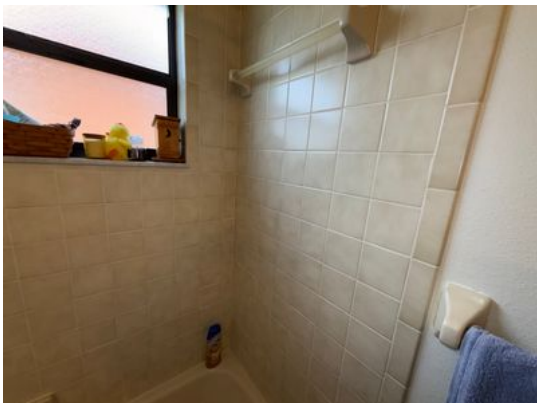
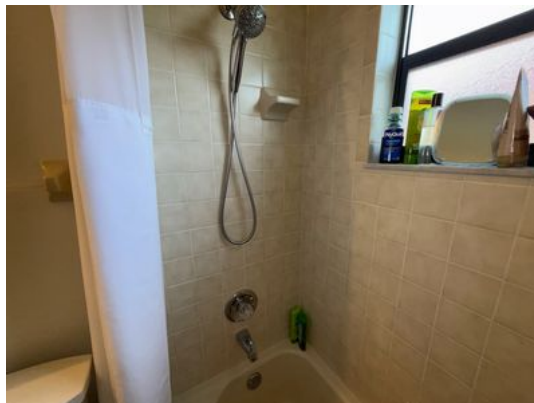
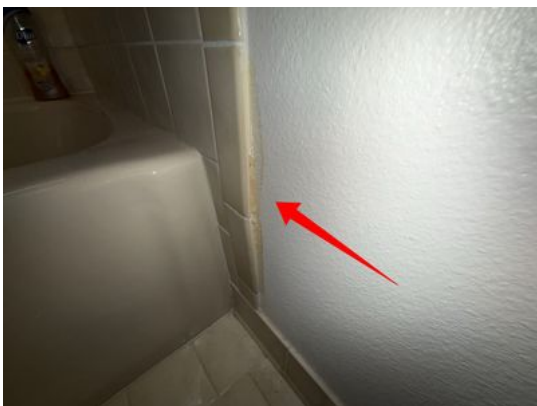
Tub Surround

Condition: Marginal

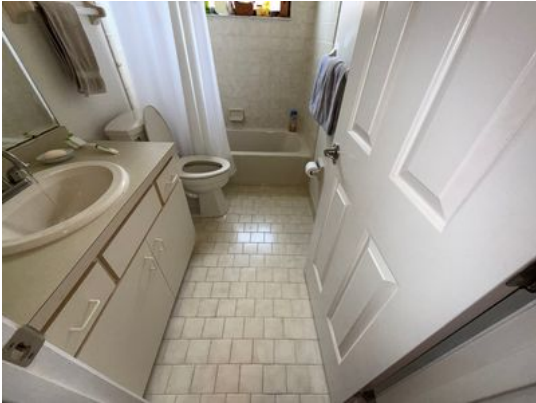
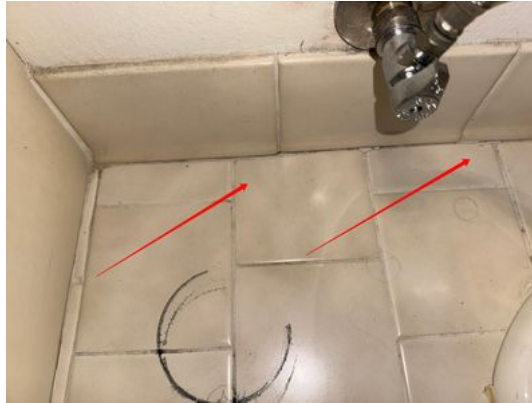
Tile

Condition: Marginal

Missing/Deteriorated Floor Grout. Several areas of the tiled floor exhibit missing, cracked, or eroded grout. The damage appears consistent with age and normal foot traffic (wear and tear). Recommend a Qualified Flooring Professional or handyman remove the loose material and regrout the affected areas. Following repair, the grout should be treated with a High-Quality Sealer to extend its service life.

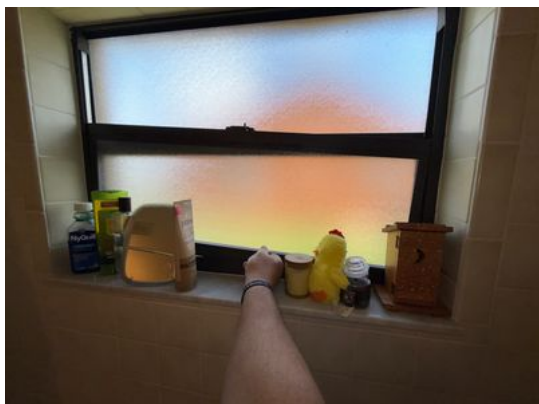
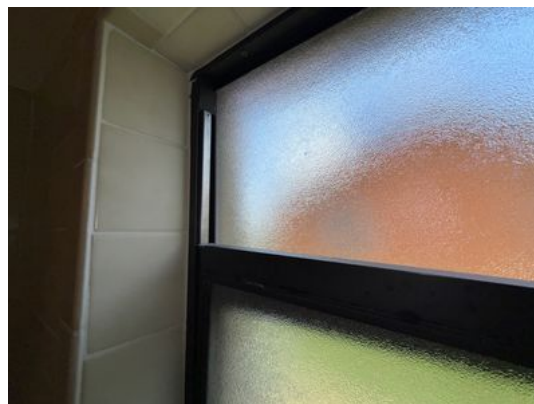
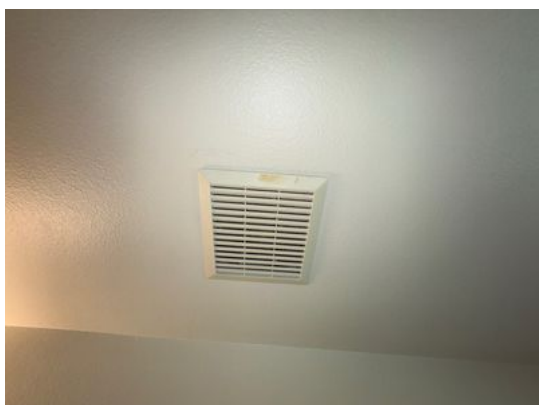
Ventilator, Window

Condition: Repair or Replace

All Windows have been mentioned earlier in the report.

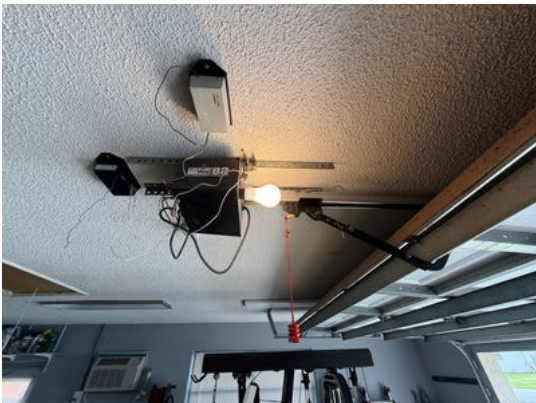
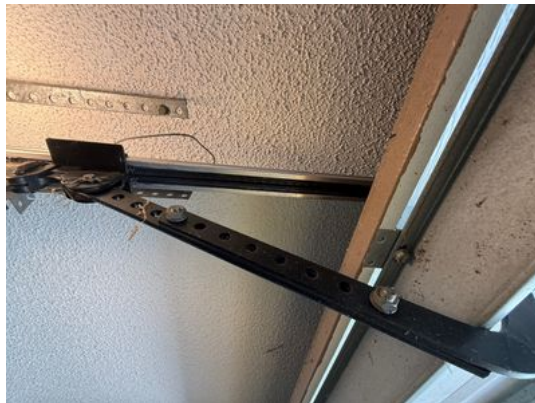
Door Opener

Condition: Repair or Replace

Missing Photo-Electric Safety Sensors (Safety Eyes). The automatic garage door operator is missing the required photo-electric safety sensors designed to detect obstructions in the door's path. Entrapment Risk: Without these sensors, the door may not automatically reverse if a person, pet, or object is underneath it during closure. This poses a significant risk of serious injury or death from crushing. Code Non-Compliance: Automatic openers manufactured or installed after January 1, 1993, must be equipped with a secondary entrapment protection system (like safety eyes) to meet UL 325 standards. Immediate Repair Required. A Qualified Garage Door Technician should be engaged to install a compatible safety sensor kit. If the existing opener is an older model (pre-1993) that cannot support sensors, the entire motor unit should be replaced with a modern, compliant system.

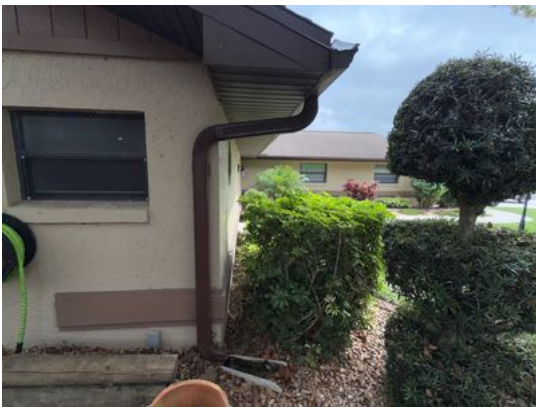
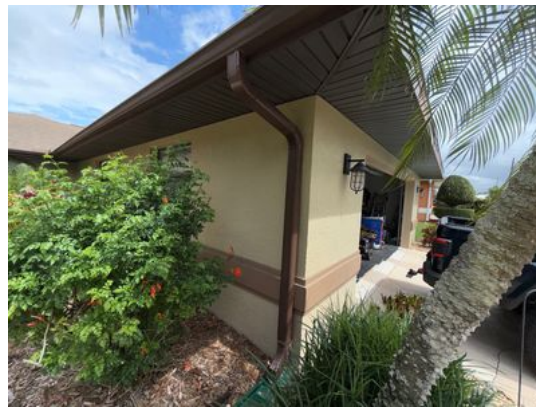
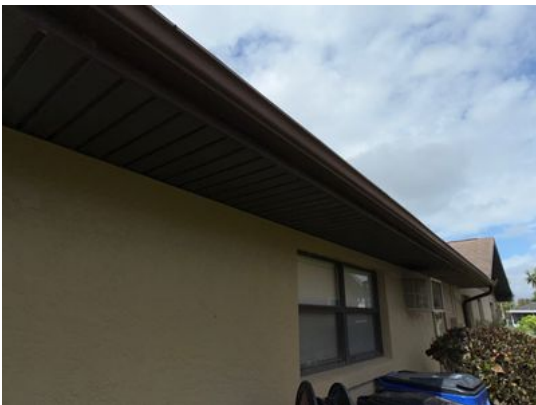
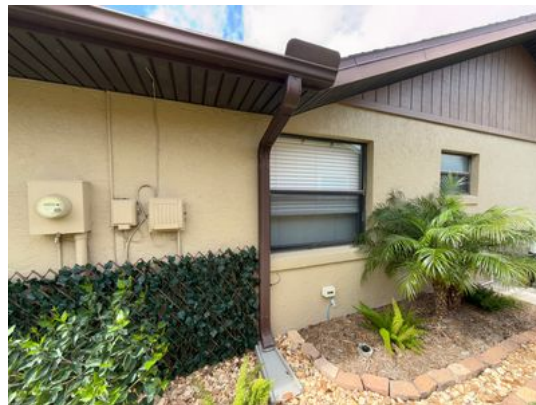
Metal

Condition: Satisfactory
